Raised Rehab

A rehabilitated lift bridge completes 100 years of Erie Canal service and is poised for another 100.

STEEL CENTURIONS SPANNING 100 YEARS

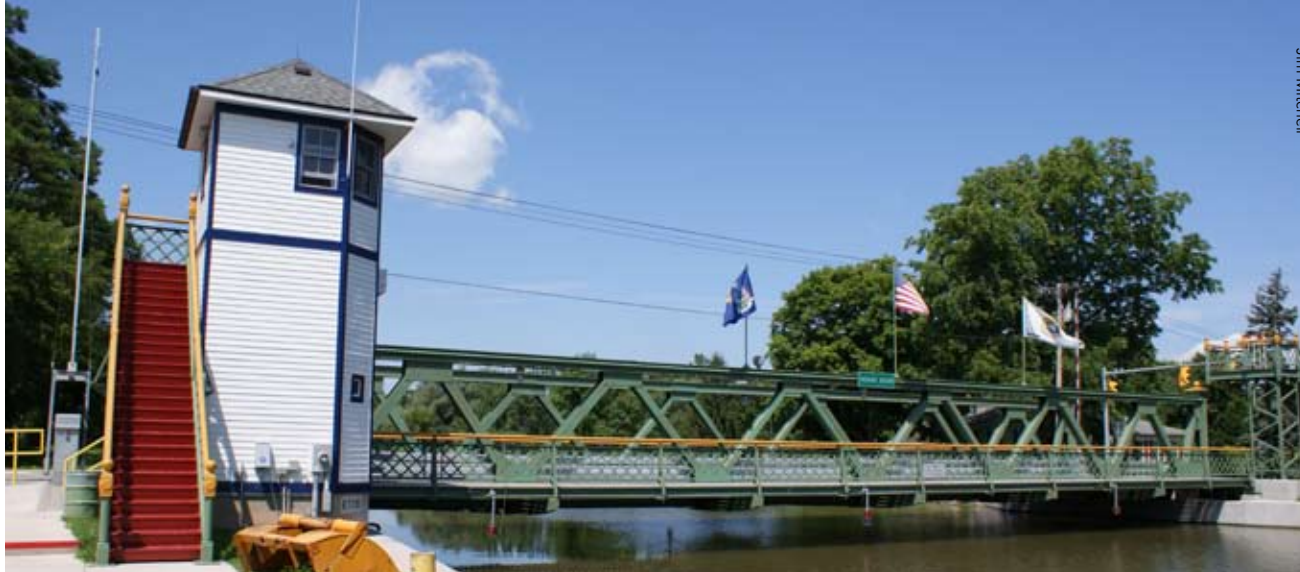
◀ The Washington Street Lift Bridge turned 100 this year.

Structurally, the design of the Washington Street Bridge is a rivet-connected Warren pony truss. The bridge has a total length of 144.7 ft and a deck width of 18.4 ft. The Warren truss consists of diagonal members only—no verticals. The term "pony" means that the truss has no bracing between the top chords. The word "Cambria" stamped on the bridge indicates that the steel came from the Cambria Steel Works in Johnstown, Pa. (the same plant that supplied the Greenspot Road Centurion bridge in the June issue).

The lift mechanism used is relatively unusual. Vertical end posts extend below the deck and into the ground. When operated, the end posts rise out of the ground. Stairways from the sidewalks at each end of the bridge allow pedestrians to continue to cross the bridge even when it's in the raised position. Raised, the bridge provides about 15 ft clearance over the water. Interestingly, the operator of this bridge also works the Union Street Lift Bridge about two miles down the canal in Spencerport; the operator drives to the Washington Street bridge when notified of a boat needing to pass.

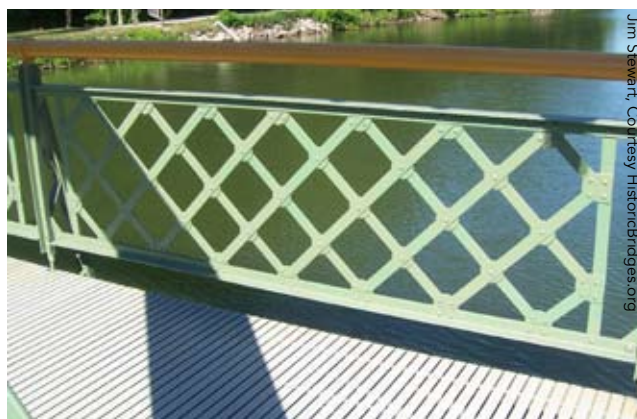
- ▲ Railing for one of the pedestrian walkways. Thanks to stairways, pedestrians can cross the bridge even in its raised position.
- ▼ Mill marking for the original steel.
