A Kentucky bridge makes a quick comeback after a ship takes out one of its spans.

Down but not Out

THE EGGNER FERRY BRIDGE took a knockout punch on January 26.

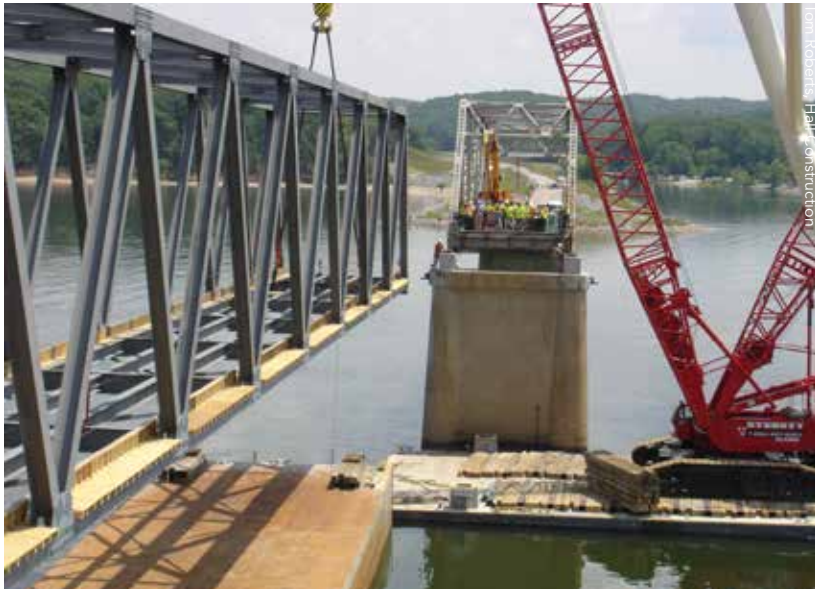
▲ The new section, shown here being lifted into place, weighs approximately 300 tons.

The barge, along with a deck barge for each of the two barge cranes needed to lift the truss onto the existing piers, arrived at the site on May 14. Deck overhang forms were installed on the barge to expedite construction, and the truss was lifted and secured in place on existing piers on May 15. Following the setting of the truss, the stay-in-place forms and studs were installed, and the concrete deck pour (with curing accelerator) was completed by May 20. The guardrail was then installed and the bridge open to traffic on Friday, May 25, two days ahead of an already aggressive schedule.

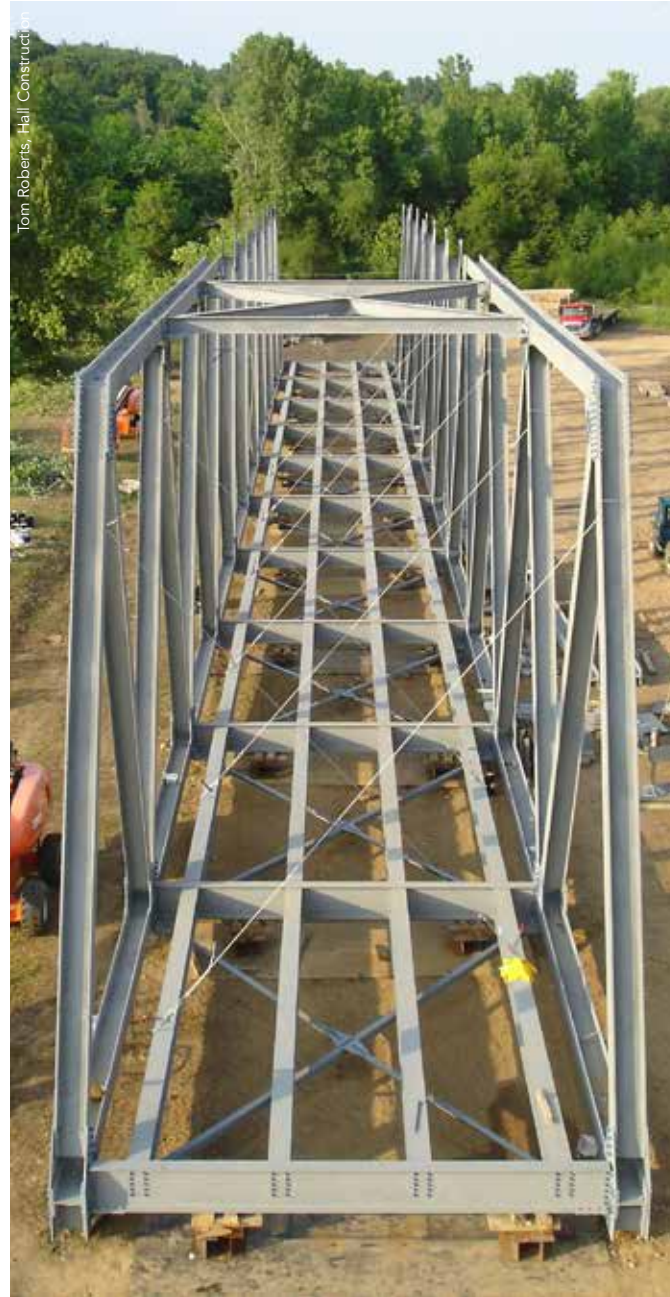
▲ The truss was assembled in less than four weeks on land adjacent to Kentucky Lake.

Thanks to the MIDAS 3D model and using lift-off points proposed by Hall, the team determined that the entire steel truss (weighing about 300 tons) could be lifted without member overstress, and Hall elected to assemble the entire truss on land adjacent to the lake, approximately 29 miles from the bridge site. The truss was assembled in less than four weeks, as gusset plates and rolled members arrived at the assembly area, and was ready to be loaded onto a barge by May 8.

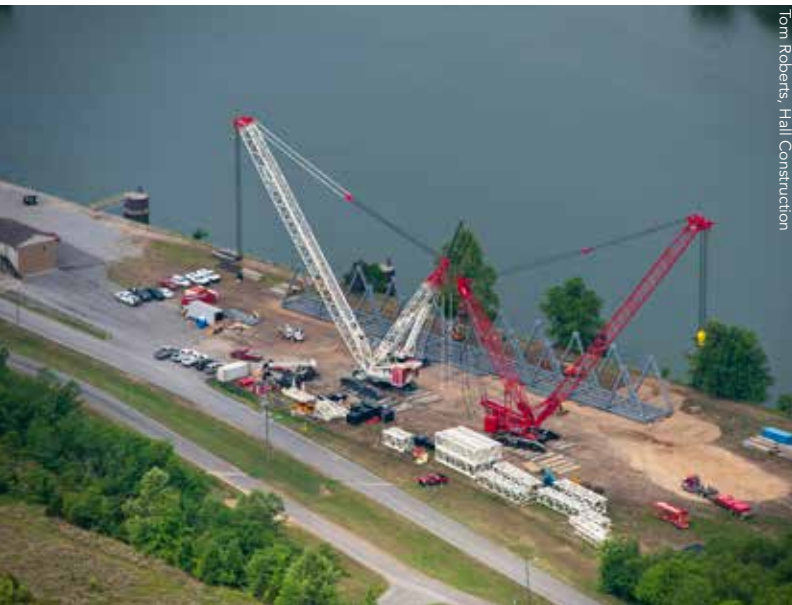
▲ The truss is assembled on the lakeshore...

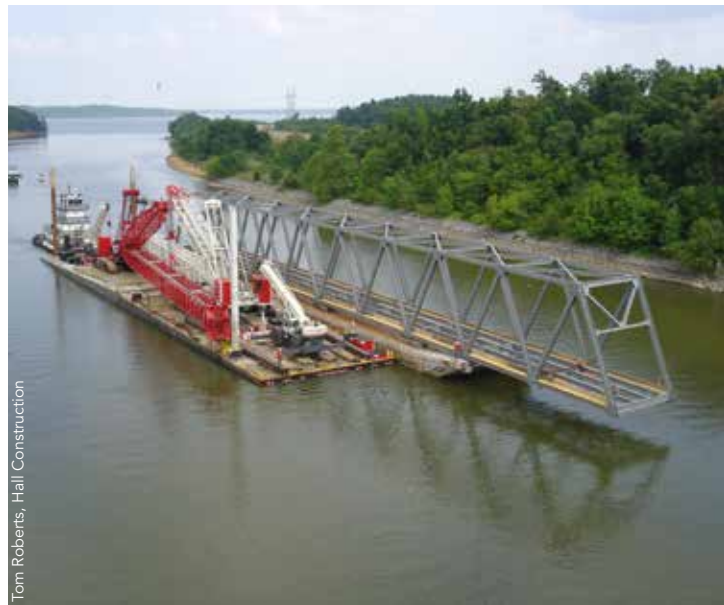
▲ ...floated to the site...

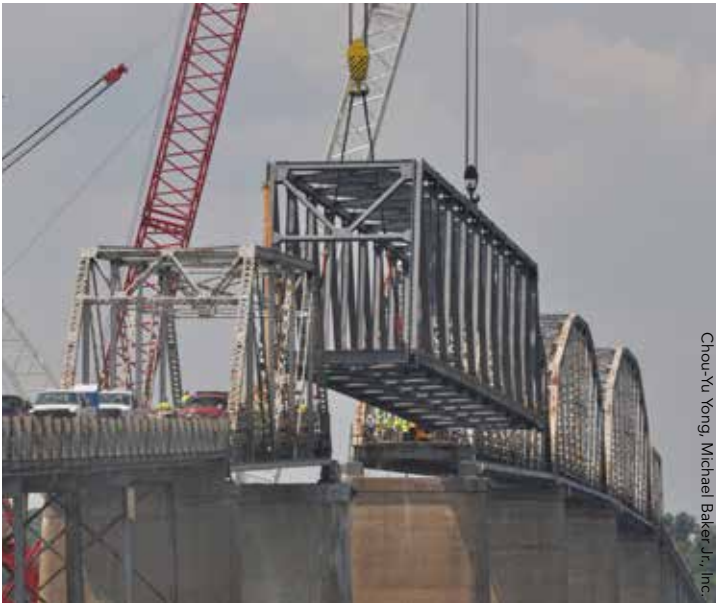
▲ ...lifted into place...

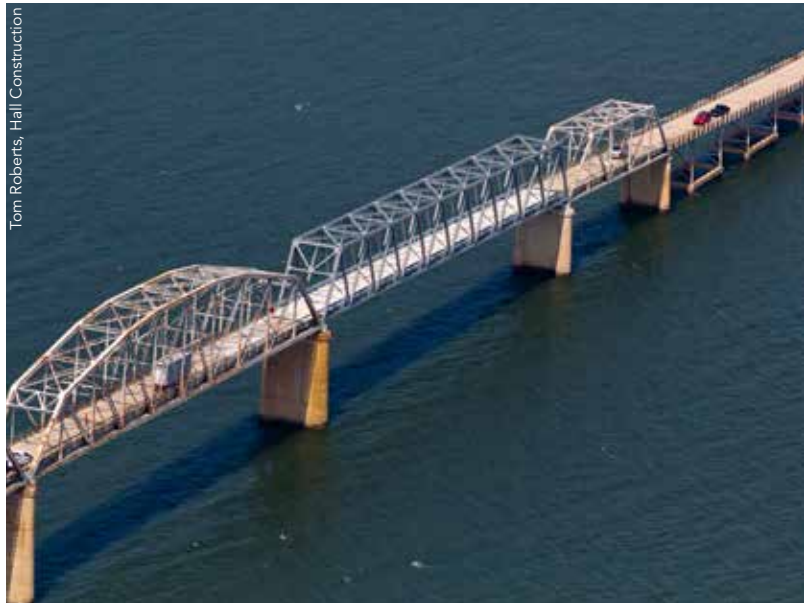
▲ ...and ready for action!

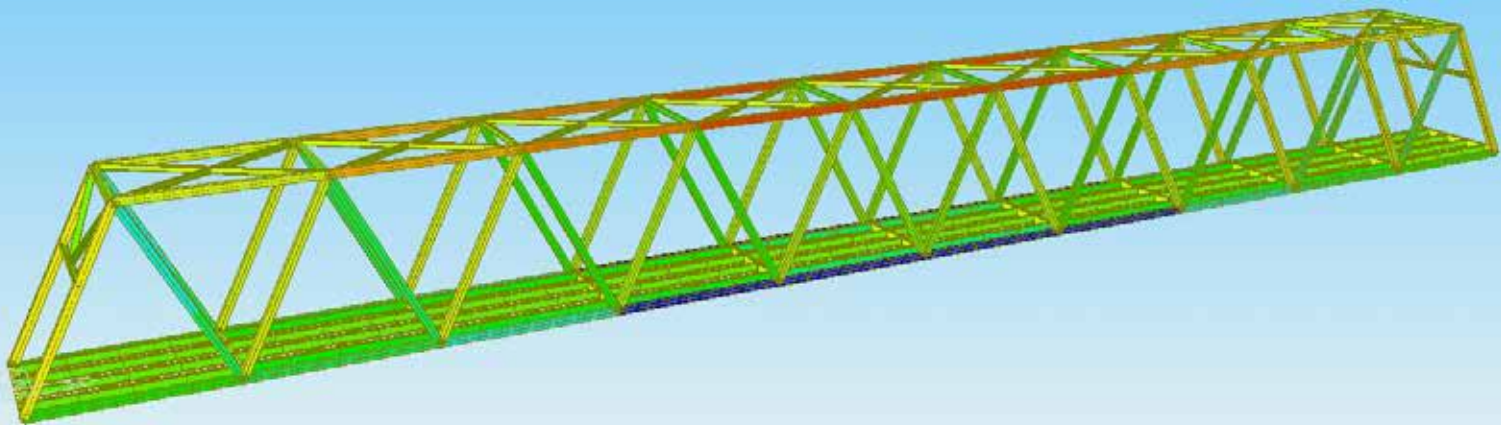
▼ A Midas Civil model of the 322-ft-section.

of simplified and repetitive connections details, as well as common member sizes, trumped weight savings for the critical-path construction schedule. The team used MIDAS Civil, a 3D finite element analysis program, to model the truss and the integral floor system and composite concrete deck. Members were designed with in-house code checking spreadsheets and the final truss design was independently checked using the AASHTOWare Virtis software. HP16×183 sections were used for the top chord and end diagonals, HP16×121 sections were used for the bottom chord and HP16×88 sections were used for the remaining diagonals. The top bracing and struts all consisted of W12×40 sections, and the integral floor system was made up of W18×86 stringers and W24×103 floor beams. Therefore only six different rolled sections were used, which helped get the mill order accepted for an early April rolling. This, along with close coordination with the steel detailer (Tensor Engineering), allowed the shop drawings to be completed, reviewed and stamped in less than three weeks.
