Emergency steel spans reopen  
an Interstate river crossing shortly after a bridge collapse.

# QUICK Thinking

BY WILLIAM KILLEEN, P.E.

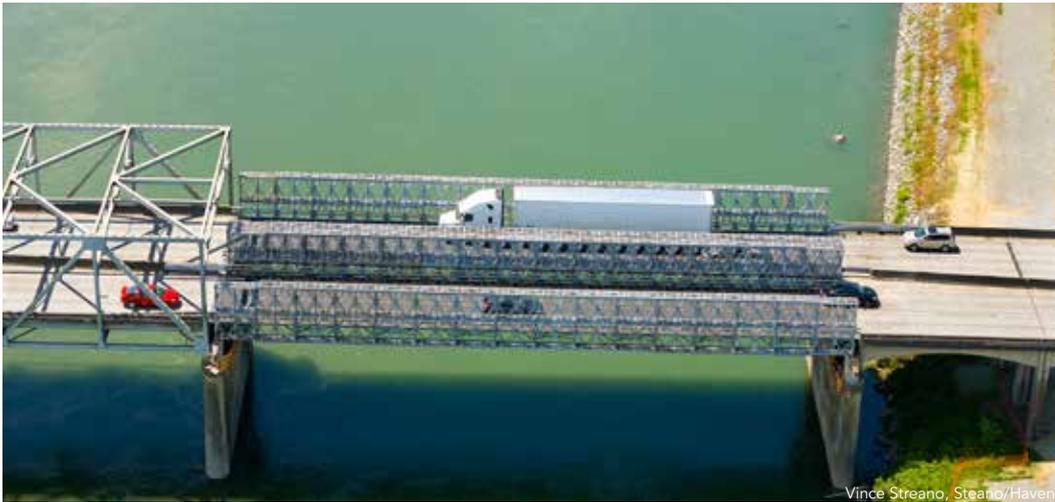
Temporary spans were erected, and the bridge reopened only 23 days after the collapse.

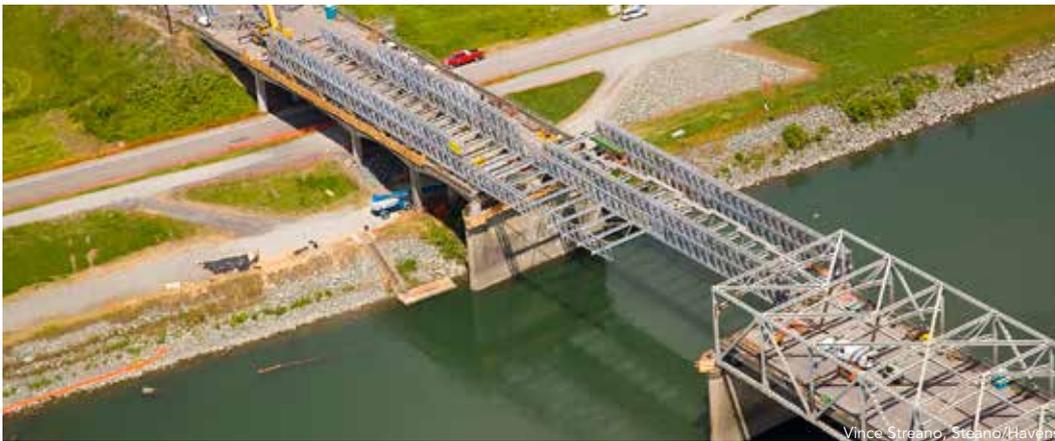
Erection of the temporary spans.

span through truss was an obstruction. The only workable approach for putting the emergency bridges into place was by rolling each bridge across the gap in full cantilever, balancing each span like a large playground seesaw, without the use of a crane.

To facilitate the installation, the bridge pedestals were designed to allow for the sliding of the bridges sideways on Hilman rollers, which was necessary because the existing through truss was 8 ft narrower than our structures. Once the pedestals were in place, the first bridge (northbound lanes) was rolled into place, jacked down onto the rollers, moved eastward, cantilevered over the bridge pedestals and positioned out of the way to make room for the second bridge (southbound lanes). The second bridge was jacked down and positioned on permanent bridge bearings, 6 in. from the first bridge, and the deck was then situated and asphalted.

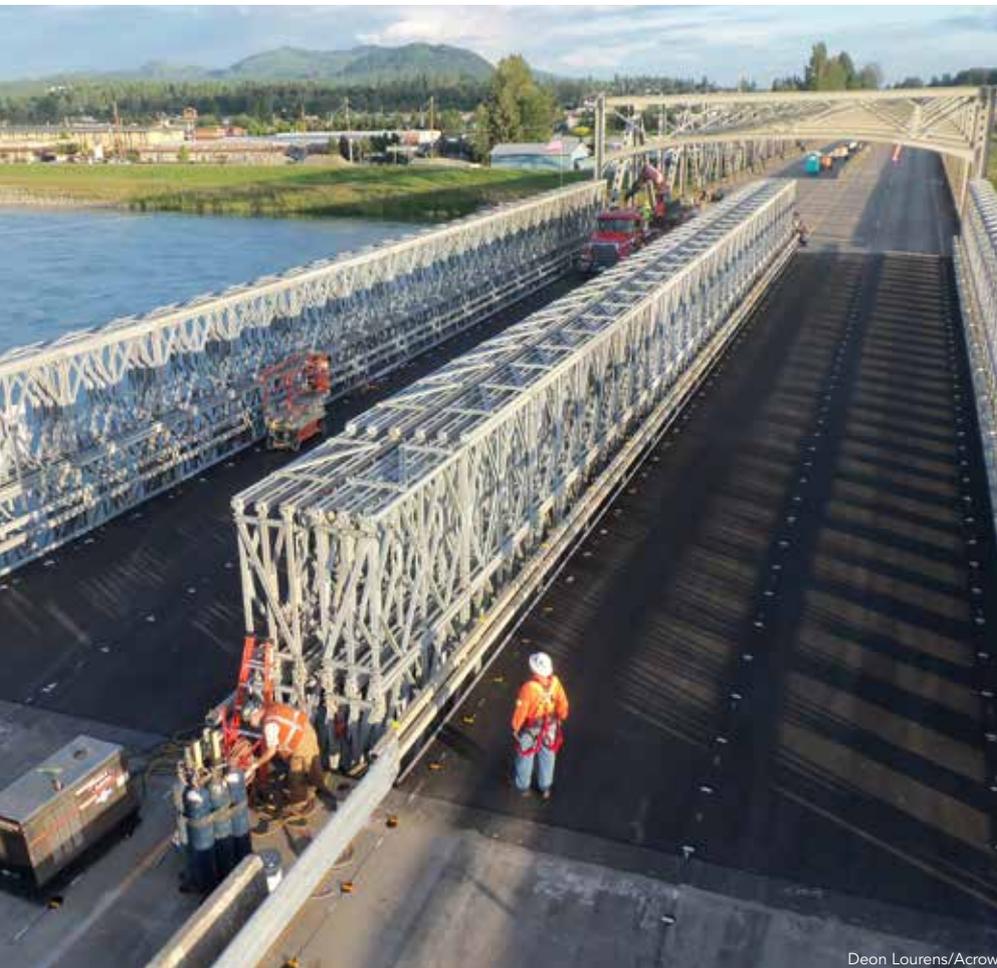
◀ Two 160-ft spans, weighting 180 tons each, were installed via Hilman rollers.
