EMBRACE YOUR BRACES!

BY TERRI MEYER BOAKE

Exposing seismic bracing not only provides new architectural possibilities, but also makes structural framing inspection easier in the event of an earthquake.

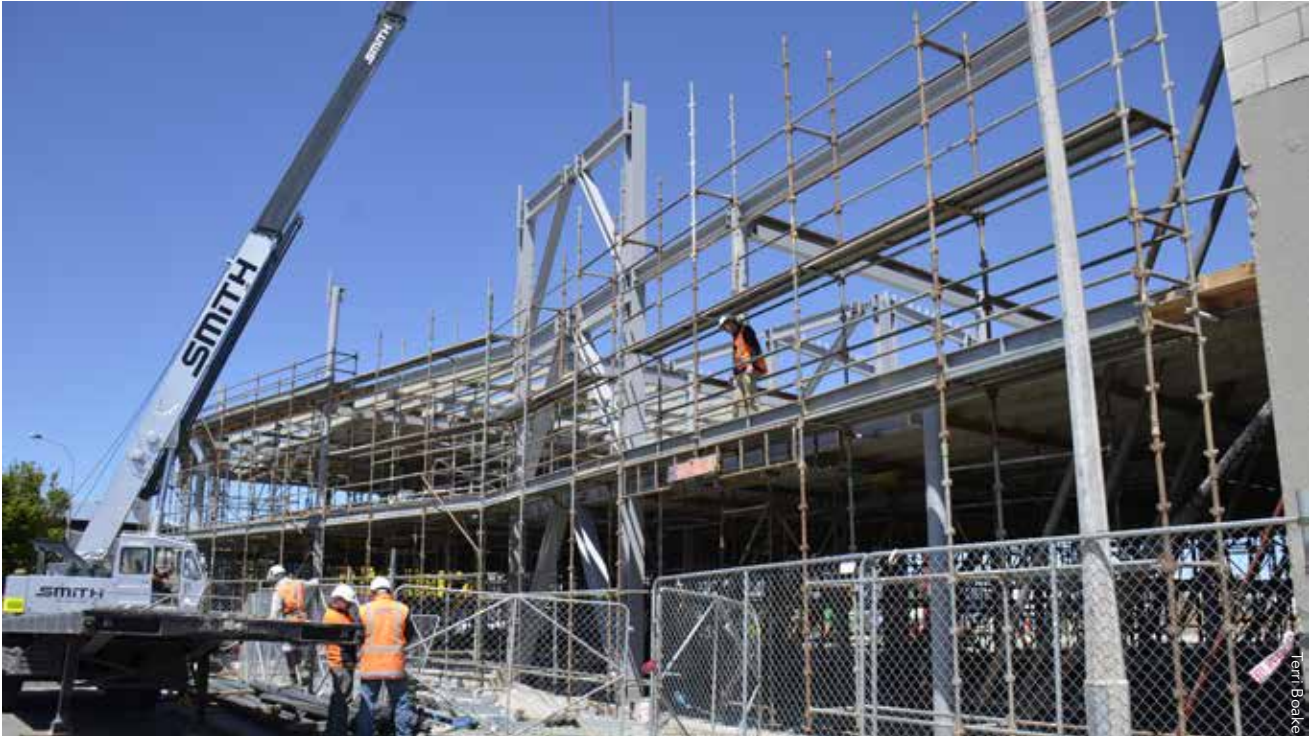
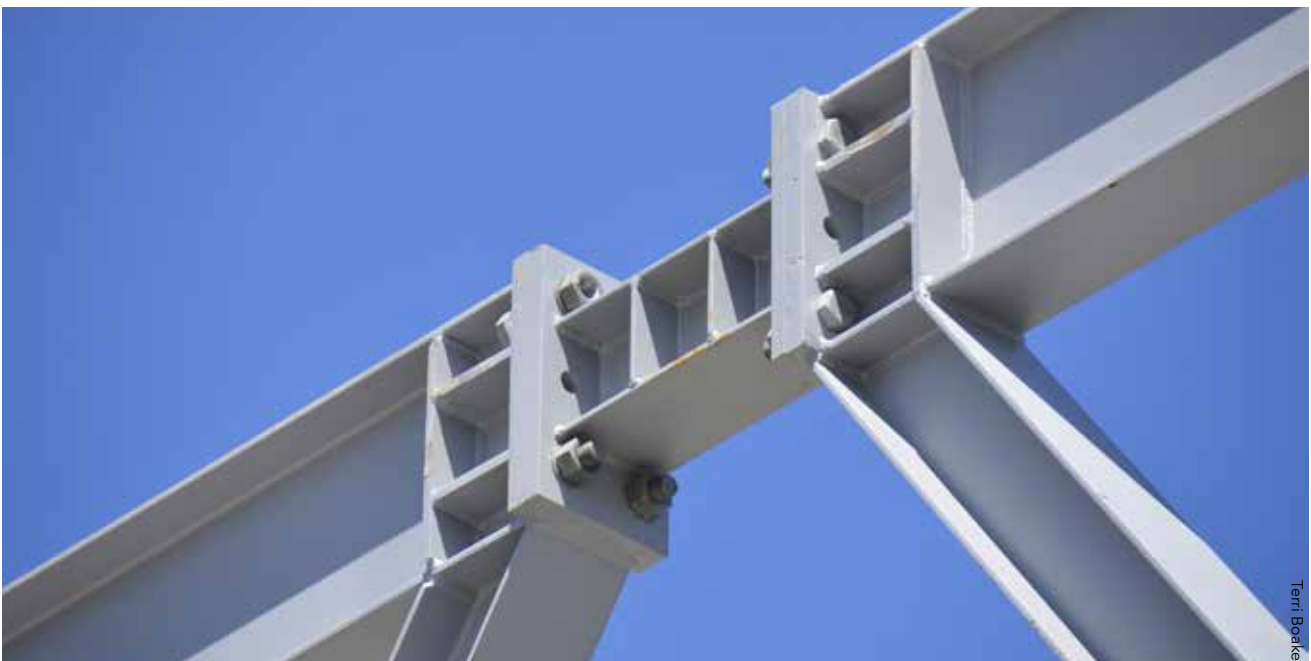
- A braced frame in Christchurch's Three35 project using a "replaceable link" in post-earthquake construction.

If this link remains exposed, then inspection and replacement become quite straightforward. What is unique about this approach is the way that the link is bolted into the frame. Up to this point the link in an EBF system was integral to the spanning member. If the link failed, it would have to be cut out and a new section welded into place. By using a short

wide-flange section, with plates welded to the ends, bolted to the frame, the failed link need only be detached and a new link bolted into place (after realignment of the brace elements).

The system has already been used in the recently constructed Three35 project in Christchurch, designed by Jasmx Architects. SCNZ (Steel Construction New Zealand), in conjunction with HERA (Heavy Engineering Research Association) and Associate Professor Charles Clifton from the University of Auckland, is currently updating HERA report R4-76 “Seismic Design of Steel Structures” to include replaceable links, partially based on experience with this project.

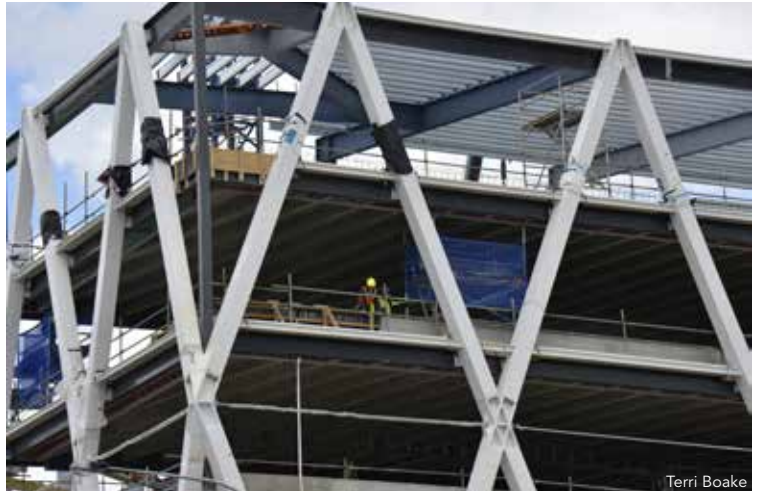
- ▲ The Manukau Institute of Technology in Auckland, New Zealand, designed by Warren and Mahoney Architects, uses a perimeter diagrid on its exterior to purposefully express the structure. Note the absence of vertical columns. EBFs are used on the building interior to assist with seismic resistance. These are left exposed.
