A historic concrete bridge near New York City
was replicated—in steel. And most people will never know.

HIDDEN Marvel

But it's also the nickname of a portion of the Crane Road Bridge, a nearly century-old crossing in north suburban New York City.

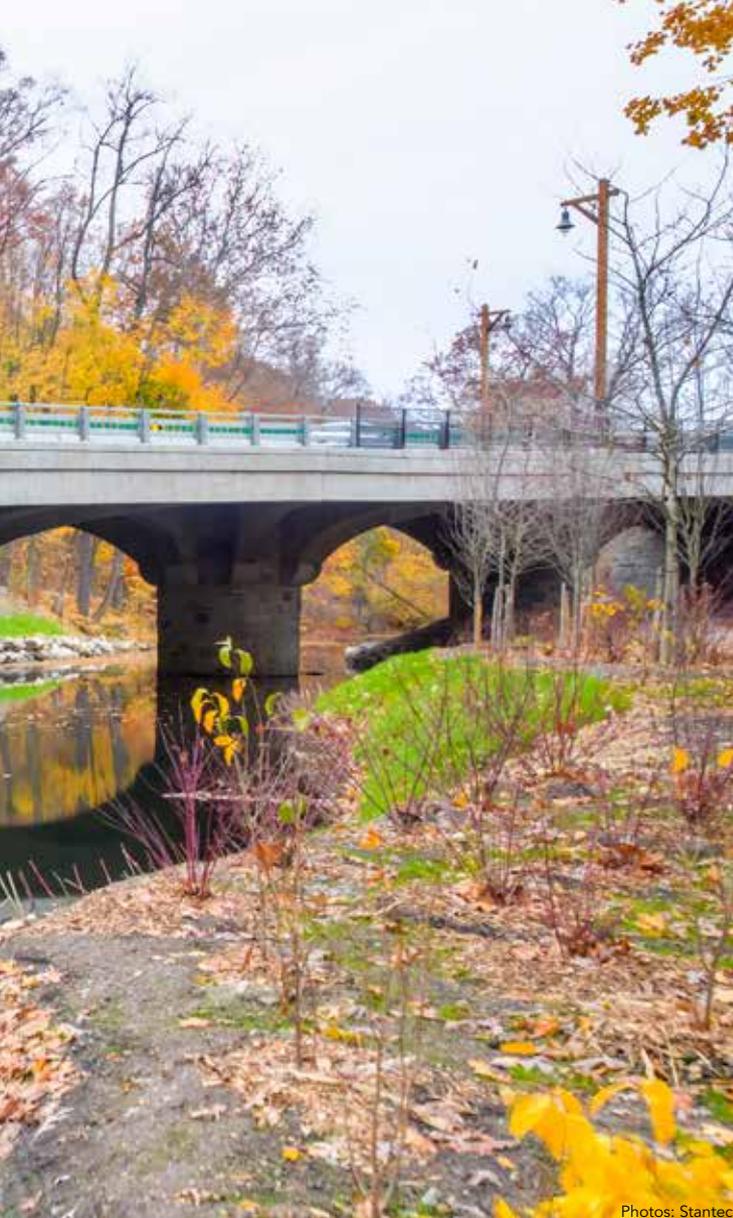
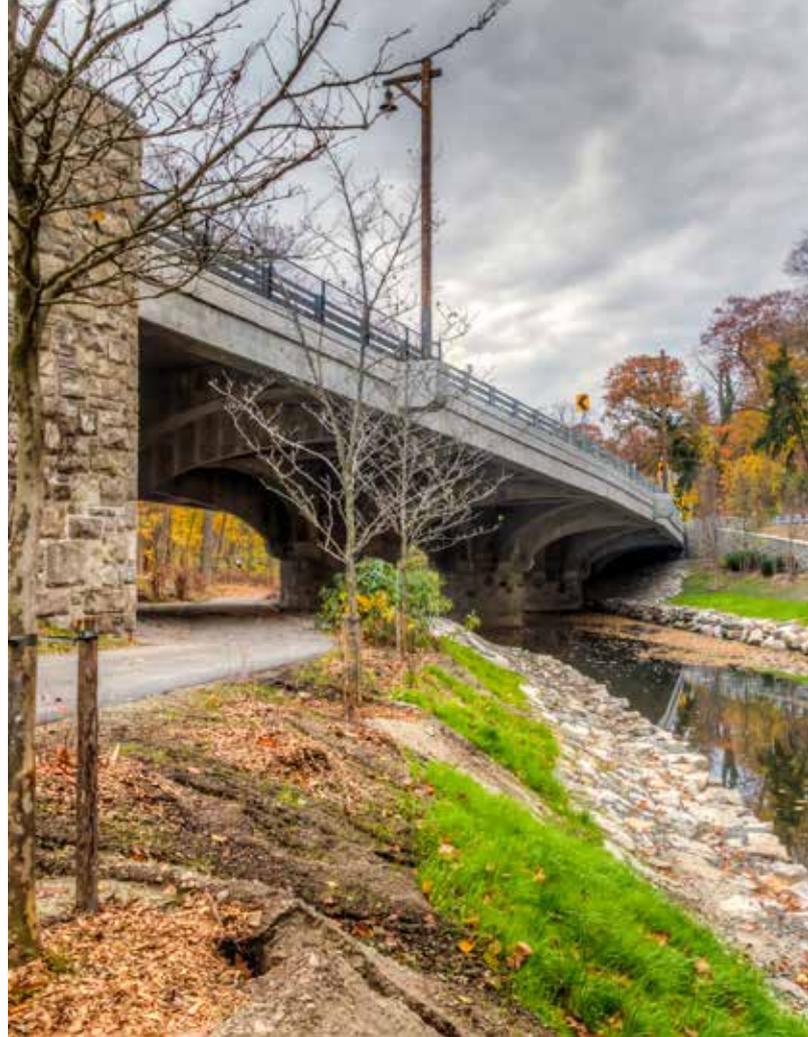
- ▲ Pedestrian use and access to the bridge was improved with the reconstruction.
- ◀ The new bridge alignment enhances the historic bridge's roadway geometry.

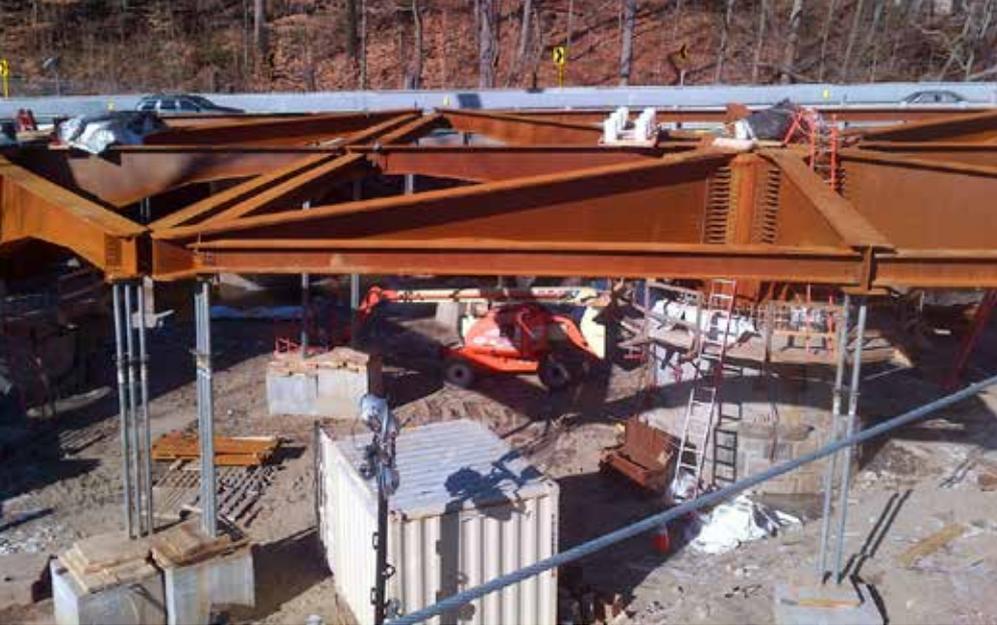
▲ The partially erected Mushroom Bridge, showing steel core and steel brackets.

using reinforced concrete brackets in the new design proved to be impossible due to rebar congestion. In order to address the unique configuration of the superstructure, an innovative steel option was used in which an octagonal core made up of steel plates was fastened to the concrete pier.

The steel core is made up of 1¼-in. steel side plates and 2½-in. top plates. Steel brackets protrude from each face of the core and are spliced to steel ring plates at the top of the core. To provide access for bolting, the top plates were designed as rings, leaving a 3-ft diameter opening in the center. A bottom flange shelf support and web connection, along with horizontal stiffeners to combat the prying action, complete the bracket connection to the core.

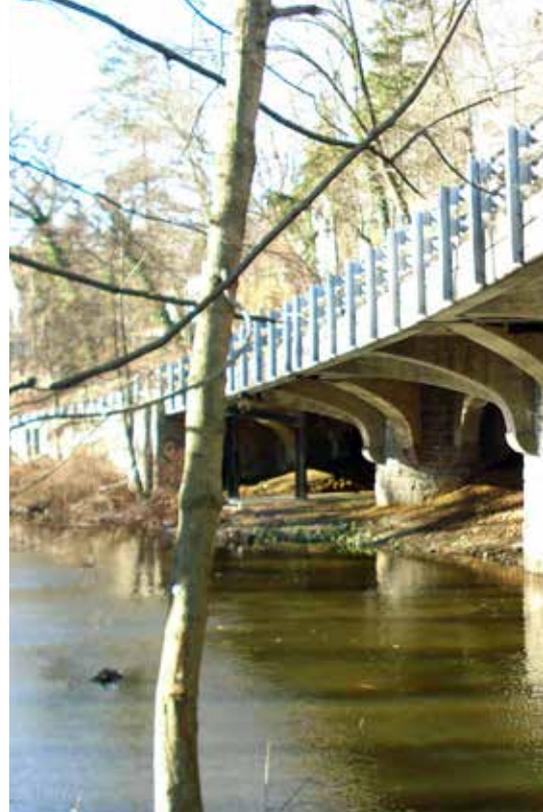
◀ The bridge's concrete-encased brackets and core.

built-up plate brackets were designed with varying depths to decrease the weight and allow replication of the existing curved arch brackets. The perimeter of each 60-ft by 60-ft deck panel was lined with rolled steel edge and fascia beams that connect to the tips of the cantilever built-up steel brackets. The entire steel solution was encased in concrete to maintain the overall aesthetic of the existing bridge.

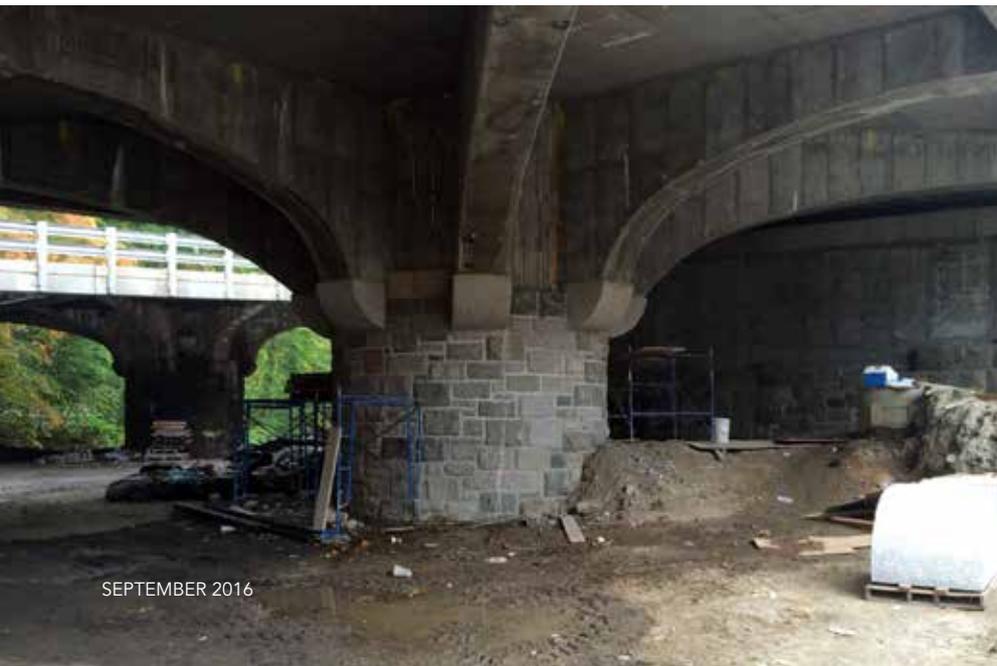
◀ Existing bridge in the background; replicated structure in the foreground.

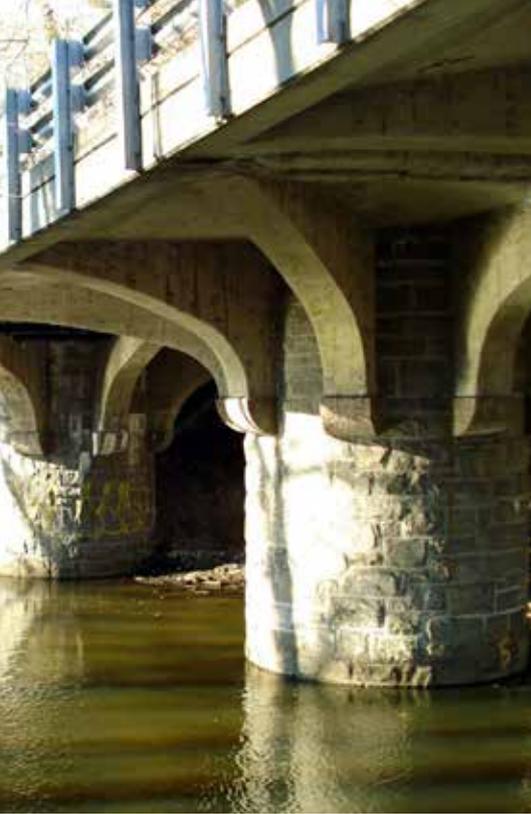
▲ The bridge's uniquely shaped piers gave it its Mushroom Bridge nickname.
