A historic concrete bridge near New York City
was replicated—in steel. And most people will never know.

HIDDEN Marvel

BY CHRISTIAN WIEDERHOLZ, PE

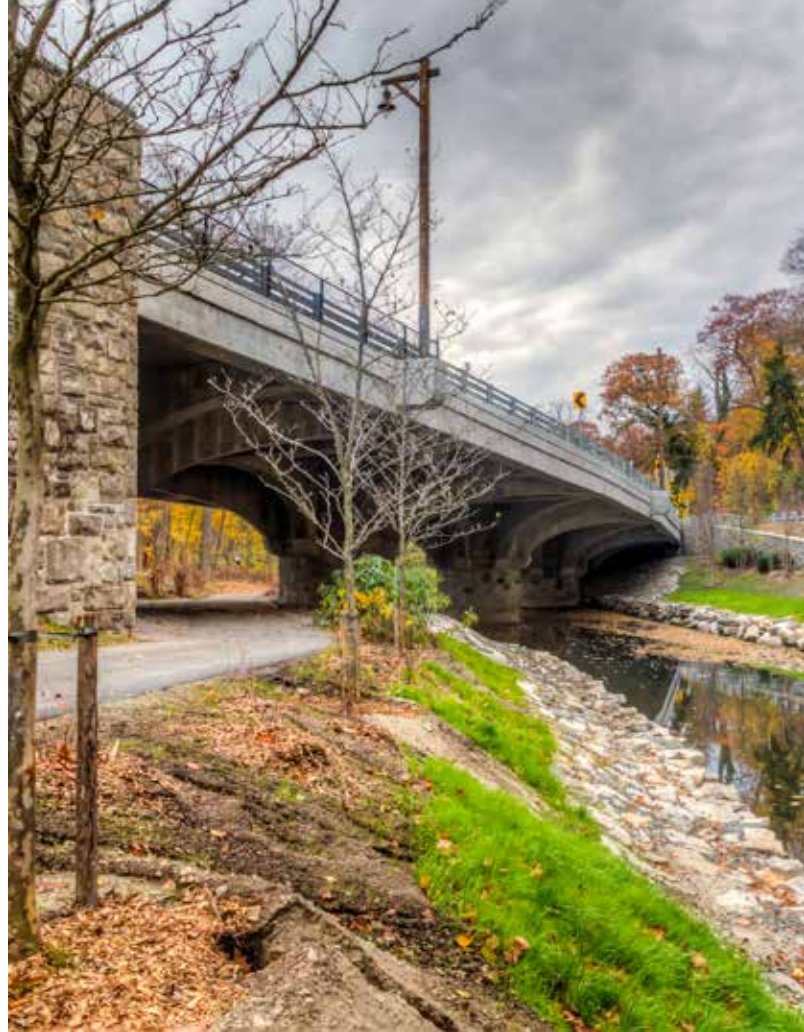
- ▲ Pedestrian use and access to the bridge was improved with the reconstruction.
- ◀ The new bridge alignment enhances the historic bridge's roadway geometry.

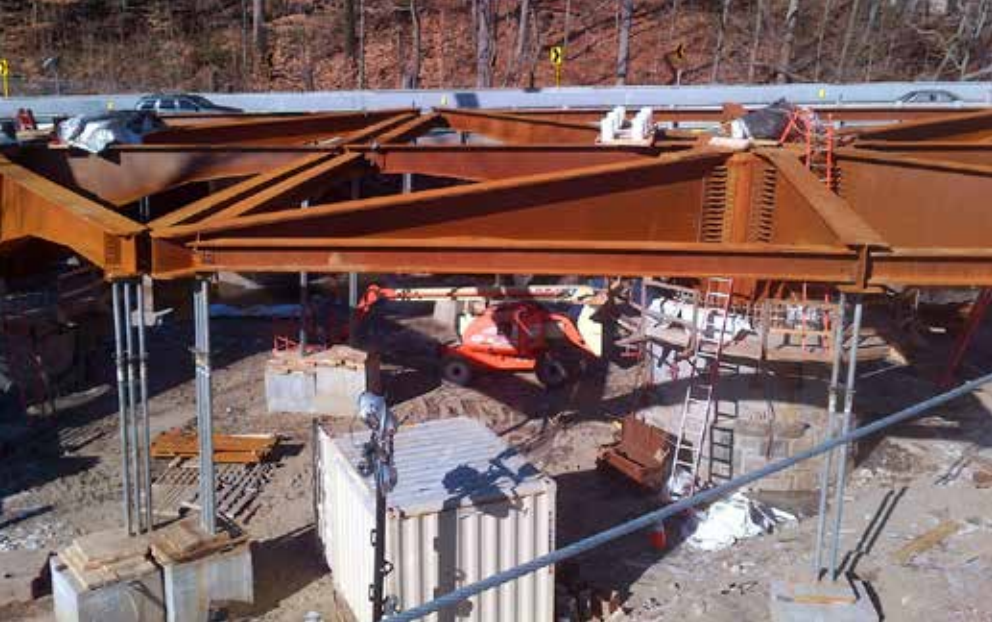
▲ The partially erected Mushroom Bridge, showing steel core and steel brackets.

using reinforced concrete brackets in the new design proved to be impossible due to rebar congestion. In order to address the unique configuration of the superstructure, an innovative steel option was used in which an octagonal core made up of steel plates was fastened to the concrete pier.

The steel core is made up of 1¼-in. steel side plates and 2½-in. top plates. Steel brackets protrude from each face of the core and are spliced to steel ring plates at the top of the core. To provide access for bolting, the top plates were designed as rings, leaving a 3-ft diameter opening in the center. A bottom flange shelf support and web connection, along with horizontal stiffeners to combat the prying action, complete the bracket connection to the core.

Further complicating the custom steel core were the longitudinal and transverse slopes of the roadway, as well as the curvature of the bridge. As a result, each octagonal core was unique. But while the top of the core was sloped in two directions, the top flanges of the brackets were level, so tapered shims were required to facilitate the bolted connection.

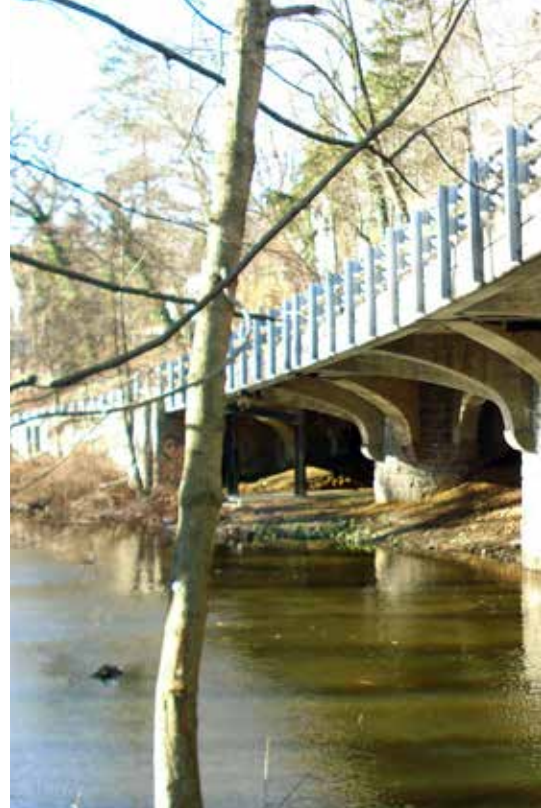
◀ The bridge's concrete-encased brackets and core.

built-up plate brackets were designed with varying depths to decrease the weight and allow replication of the existing curved arch brackets. The perimeter of each 60-ft by 60-ft deck panel was lined with rolled steel edge and fascia beams that connect to the tips of the cantilever built-up steel brackets. The entire steel solution was encased in concrete to maintain the overall aesthetic of the existing bridge.

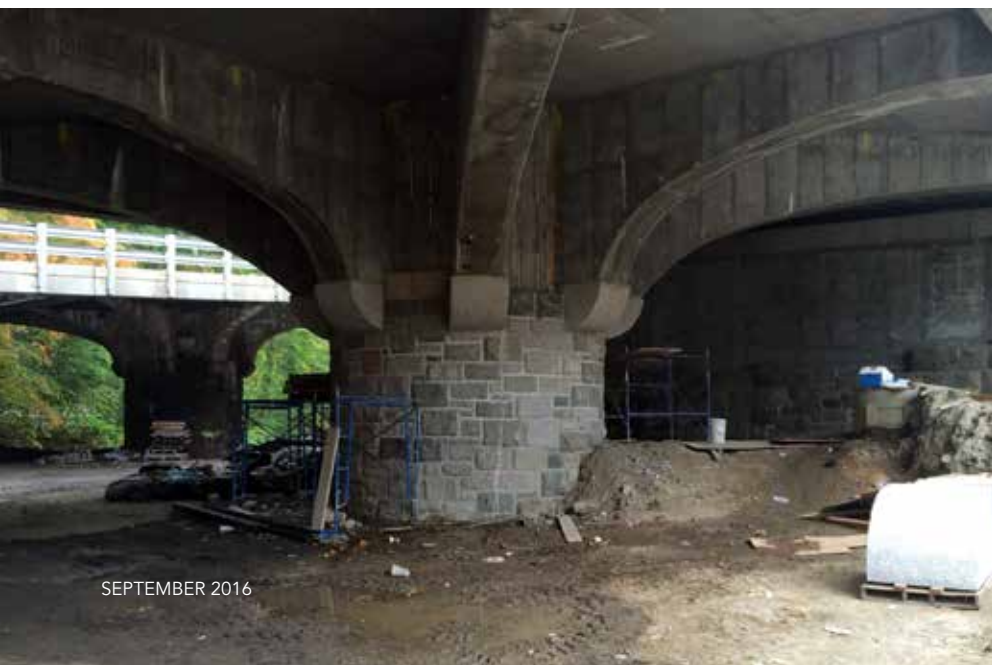
◀ Existing bridge in the background; replicated structure in the foreground.

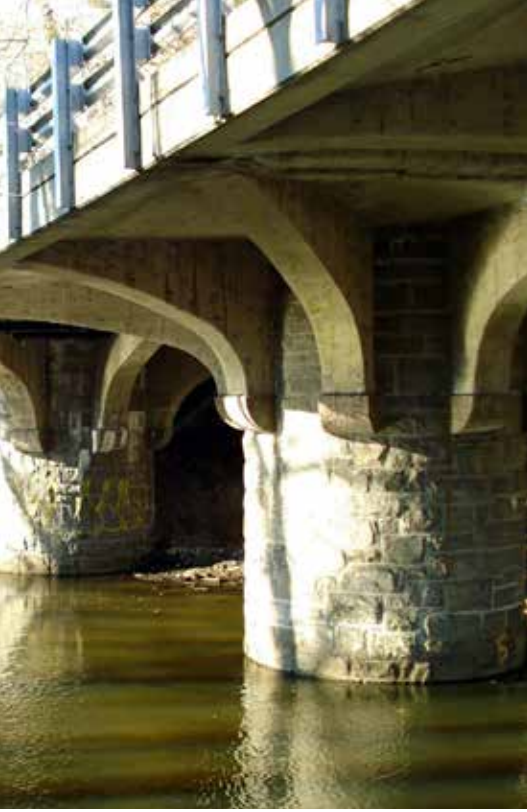
▲ The bridge's uniquely shaped piers gave it its Mushroom Bridge nickname.
