FRACTURE RESILIENCE AND REDUNDANCY OF BUILT-UP STEEL GIRDERS

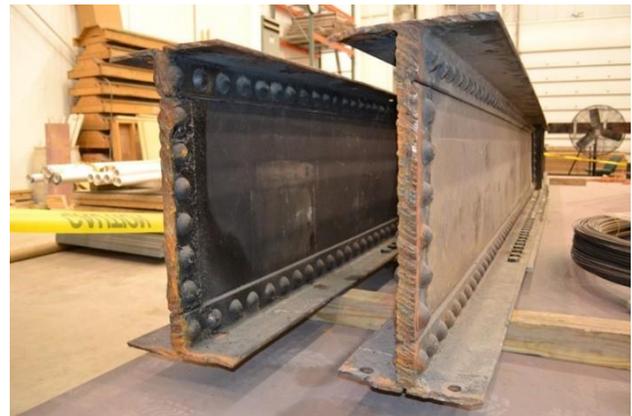
Figure 1: Typical historical built-up specimens

Fifteen large-scale built-up specimens were tested as part of this research. Specimen lengths ranged from 24'-0" to 40'-0", with web depths ranging from 23" to 46". Three historical specimens were obtained from a bridge which was being removed from service (see Figure 1). The remaining twelve specimens were fabricated with new material. Thirteen of the specimens used component dimensions and proportions typical of built-up construction. Two of the specimens, intending to determine an upper bound to fracture resilience, used proportions which were extraordinary and unrealistic. Both riveted and high-strength bolted specimens were evaluated. Other parameters which were investigated included the number of bottom flange cover plates per specimen, the contribution of friction between built-up member components, and the method of hole fabrication (punched vs drilled).

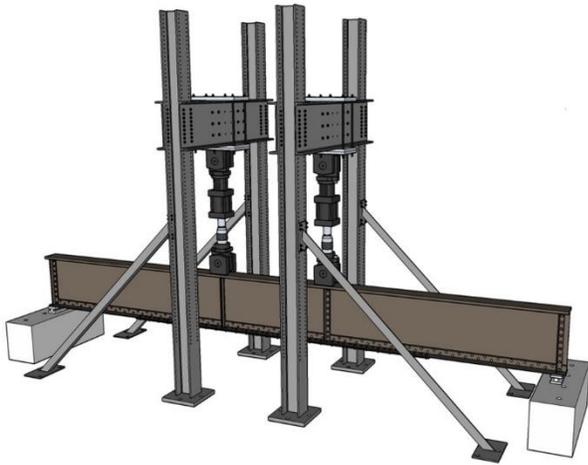
Specimens were loaded in four-point bending using two 220 kip hydraulic actuators as shown in Figure 2. This created a constant moment region which facilitated the measurement of stresses in bottom flange components both before and after a component failure. Foil strain gages were used to measure the stresses at key locations in each of the bottom (tension) flange components both

longitudinally and transversely. This resulted in the ability to evaluate the localized stress distribution near a failed component both in and out-of-plane.

Figure 2: Test setup

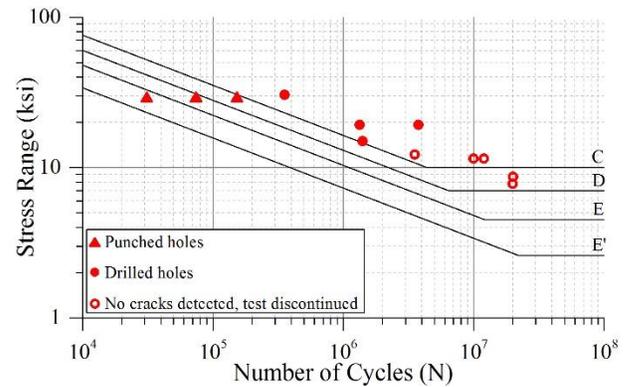
The specimens were tested at calculated net-section stress ranges (using traditional mechanics of materials calculations on the partially failed cross-sectional geometry) which varied from 6.6 ksi to 25.6 ksi. The range of stress ranges was used in an effort to capture fatigue behavior over a wide spectrum. After experimental and analytical evaluation, it was found that localized stresses were amplified near the failure region. Therefore, the resulting amplified stress ranges (which reflected true conditions in the components) were between 7.8 ksi and 30.5 ksi. The resulting fatigue data was plotted against the AASHTO fatigue curves and can be seen in Figure 3.

Figure 3: After-failure fatigue life

The fatigue data from the different specimens was evaluated to determine which parameters impacted the remaining fatigue life of built-up steel specimens. The parameter that had the largest impact on the remaining fatigue life was the method of hole preparation in the built-up specimen components. Other parameters investigated that did not appear to have an influence on the remaining fatigue life were: the contribution of friction, non-symmetric cross-section, the number of tension flange components, and the fastener type (rivets vs. high-strength bolts).

It was found that specimens with drilled holes had a substantially higher fatigue life than specimens with punched holes. This corroborates previous research in which punched holes were found to have a lower fatigue life than drilled holes or holes that were subpunched and reamed [2]. The AASHTO category E' fatigue curve was found to be a reasonable lower bound for specimens having punched holes, and the AASHTO category C fatigue curve was found to be a reasonable lower bound for specimens having drilled holes. In all cases, the remaining fatigue life tests illustrated that built-up members with partially failed cross-sections are able to sustain a substantial amount of fatigue cycles prior to any other component damage.

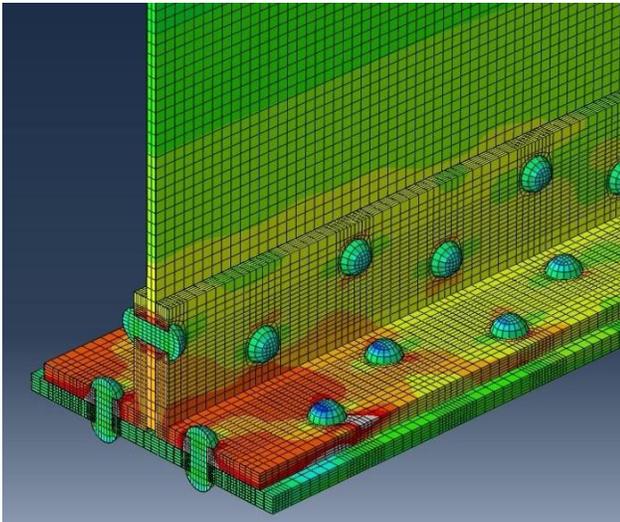
The longitudinal stress distribution in the components adjacent to a failed component was found to vary significantly throughout the transverse direction as well as the thickness of individual components (see Figure 4). In order to account for this variation throughout each component cross-section, the net-section stress of each component was found by summing the stress over the entire cross-section and then dividing by the net cross-sectional area. The resulting net-section stresses of each component were compared at discrete locations along the length of the member, with relation to the component failure location. It was found that the largest localized net-section stress was found in adjacent components in the same plane as the failure, and in the plane of the nearest fastener on either side of the failure plane.

Figure 4: Stress distribution at failed cover plate

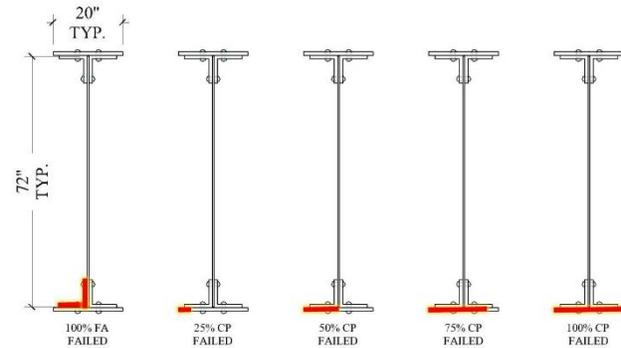
The effect of non-symmetric cross-sections on the localized stress distribution near a failed component was investigated to determine whether the resultant stress increase could affect the remaining fatigue life. Two scenarios were considered in which a non-symmetric cross section could result: the failure of a tension flange angle, and the partial failure of a tension flange cover plate. A series of ten different failure situations were evaluated for three different beam sizes; a fully failed flange angle, and nine different stages of cover plate failure. Figure 5 shows a portion of a typical model set.

Figure 5: Non-symmetric cross-section model set

The net-section stress in a single flange angle was used to compare the resulting stress increase from each of the failure scenarios. When the various stages of failure were analyzed, it was found that only scenarios where the cover plate was more than 60% failed was the stress increase in the angle greater than what would result from a fully failed cover plate (considered a symmetric cross-section). Since this scenario would represent a case where a fatigue crack was of substantial size, the crack growth rate would be expected to be rapid at this stage. The total crack length was plotted based on number of cycles for various experimentally tested specimens. The resulting duration in which the crack length would be expected to be greater than 60% of the cover plate width was found to be approximately 5%. Because of the minimal duration at which the stress increase was found to apply, the effect of non-symmetric cross-sections was

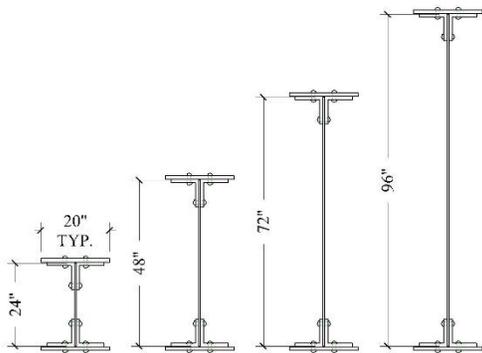
Due to the results of previous parameters, only symmetric cross-sections were considered in the web height parameter study. Four different web heights were evaluated, (24", 48", 72", and 96") as shown in Figure 6. Each of the models had a single cover plate on both the tension and compression flanges. A completely failed cover plate was simulated for each of the models. The remaining net-section stress was measured in the tension flange angles adjacent to the failed cover plate. The resulting net-section stress in each of the models was found to be less than 3% between each of the models. Therefore the height of the web was not considered to be a significant parameter in the stress distribution of partially failed built-up members.

Figure 6: Web height model set

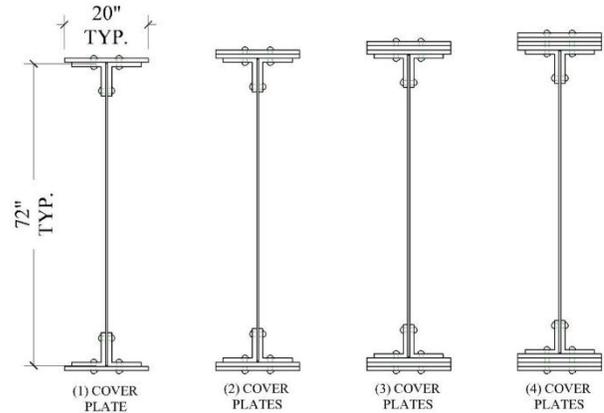
The effect of the quantity of tension flange components (cover plates and angles) was investigated to determine their effect on the redistribution of stresses adjacent to a failed component. Models were evaluated with 1, 2, 3, and

4 cover plates for three different model sizes (see Figure 7 for typical configuration).

Figure 7: Quantity of flange components model set

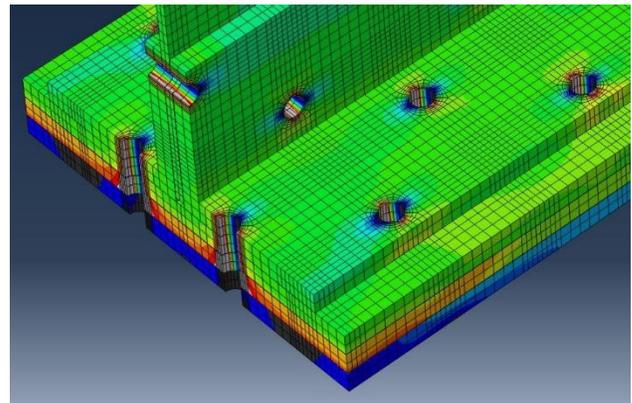
It was found that the number of cover plates of a steel built-up member has a significant effect on the stress distribution in the localized region near a failed component. Figure 8 shows the stress distribution at the failure plane for a model with three cover plates in which the lower cover plate is failed. When a component of a built-up member is failed, the load is transferred through the fasteners, into adjacent components. Based on the results of this model set, the majority of the load was found to be distributed to the component most adjacent to the failed component (e.g. for a member with two cover plates which experiences a failure of the lower cover plate, the majority of the load is distributed into the upper cover plate, while the flange angles see a minimal increase in longitudinal stresses).

Figure 8: Three cover plate model with one cover plate failure

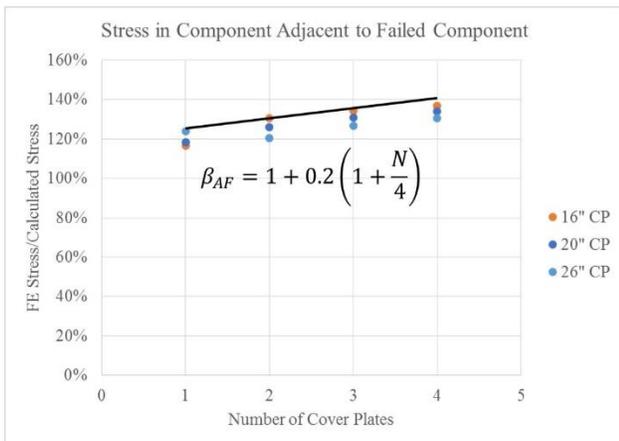
was found which relates the actual net-section stress of an adjacent component to its calculated net-section stress. The calculated net-section stress of a partially failed built-up member in bending can be found using simple mechanics of materials calculations ($\sigma = My/I$) in addition to the resulting cross-sectional geometry. The intent was to determine an amplification factor which could accurately describe the large stress distribution which is transmitted into the adjacent component. In order to determine the relationship, the data for twelve different models with 1, 2, 3, or 4 cover plates was collected (see Figure 9). For each model, the resulting net-section stress was normalized by the calculated net-section stress which is calculated using the resulting partially failed geometry of the member. The linear relationship β_{AF} (Equation 1) should be used to amplify the calculated net-section stress to conservatively account for the resulting net-section stress in a partially failed built-up member in flexure as shown in Equation 2.

Equation 1:
$$\beta_{AF} = 1 + 0.2 \left(1 + \frac{N}{4} \right)$$

Figure 9: After-failure stress distribution factor
