**FAILURE ANALYSIS OF A WELDED
MOMENT-RESISTING INTERIOR CONNECTION**

By
John. M. Barsom
and
James V. Pellegrino Jr.

Submitted to:
AISC
Chicago, IL

September 15, 2001

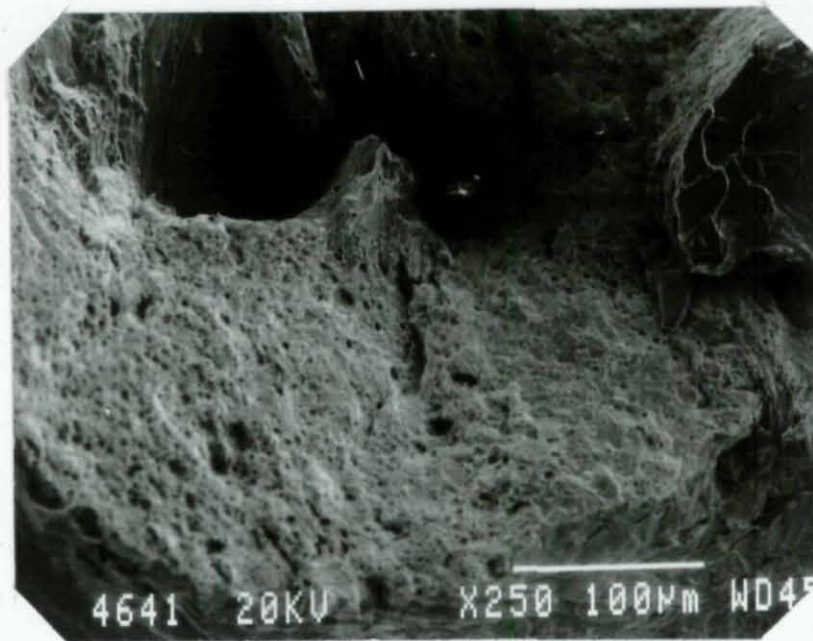
Figure 11. Examples of ductile fractures in the west-beam bottom-flange joint.

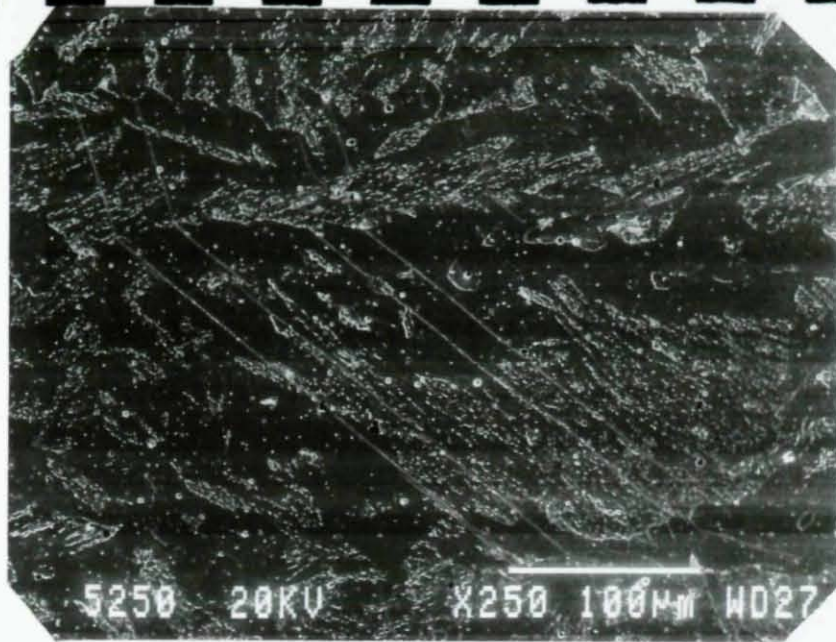
Figures 18-a, 18-b and 18-c show a cluster of intersecting crystallographic planes at 250X, 500X and 1000X magnifications, respectively. These planes which appear to be innocuous at 250X and at 500X magnifications, appear at 1000X magnification to be

Figure 18. A cluster of intersecting crystallographic planes at different magnifications.
